QUT Kelvin Grove Building N Final DFTs. Multi-Batch Inspection Report

Summary report for the various elevations where readings were compiled on the 22-12-2021.

Coating Thickness Inspection Report

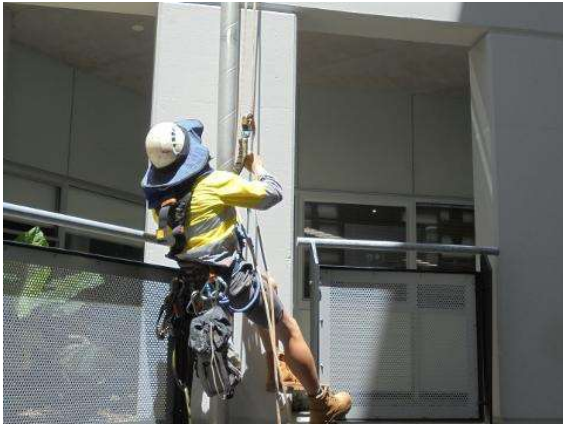
Dry Film Thickness (DFT) readings to the lower areas both internally and externally to the concrete panels at this location.

#	\bar{x}	σ	\downarrow	\uparrow
Layer 1	15	517.9	79.1	363	649

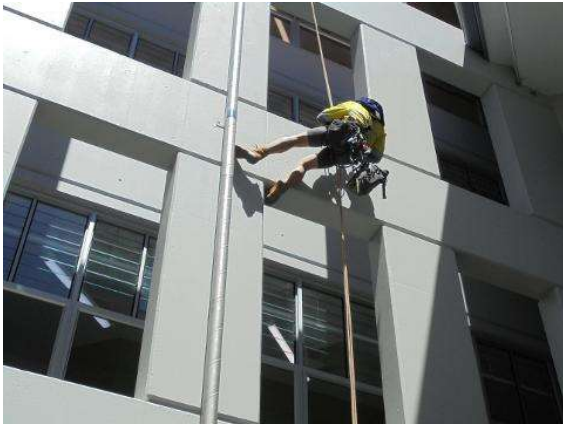
Dry Film Thickness (DFT) readings to the middle areas both internally and externally to the concrete panels at this location.

#	\bar{x}	σ	↓	↑
Layer 1	15	538.5	126.1	411	928

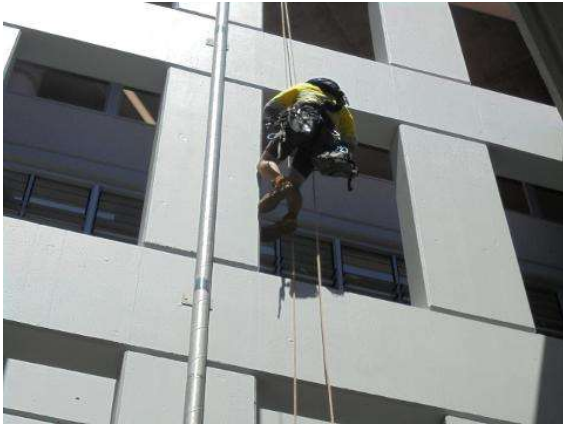
Dry Film Thickness (DFT) readings to the upper areas both internally and externally to the concrete panels at this location.

#	\bar{x}	σ	↓	↑
Layer 1	15	579.2	91.8	455	798

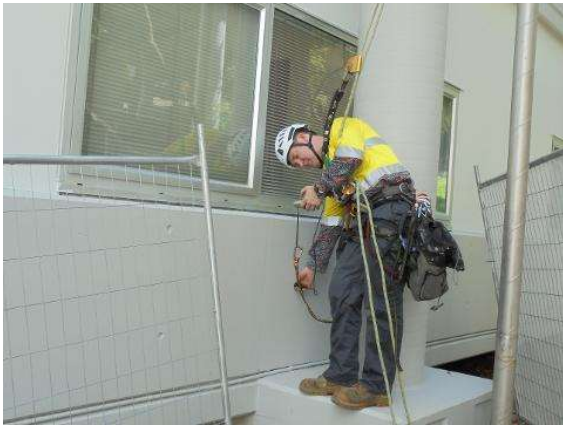
Dry Film Thickness (DFT) readings to the OFC window panel areas at this location.

#	\bar{x}	σ	↓	↑
Layer 1	15	620.2	163.9	373	873

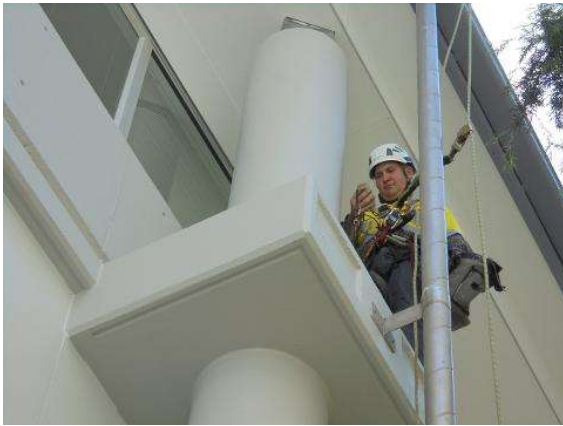
Dry Film Thickness (DFT) readings to the OFC Column Base Top areas at this location.

#	\bar{x}	σ	↓	↑
Layer 1	15	648.7	146.2	393	846

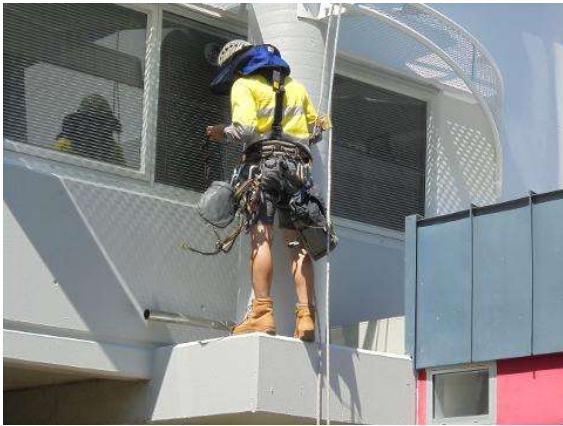
Dry Film Thickness (DFT) readings to the OFC Column Base Sides at this location.

#	\bar{x}	σ	↓	↑
Layer 1	15	656.1	135.0	361	843

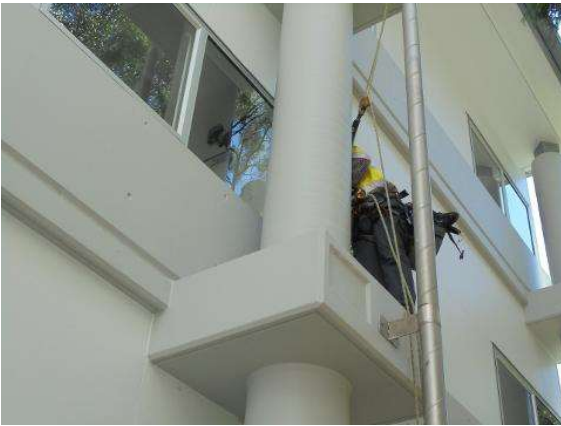
Dry Film Thickness (DFT) readings to the OFC columns area at this location.

#	\bar{x}	σ	↓	↑
Layer 1	15	646.0	150.0	374	925

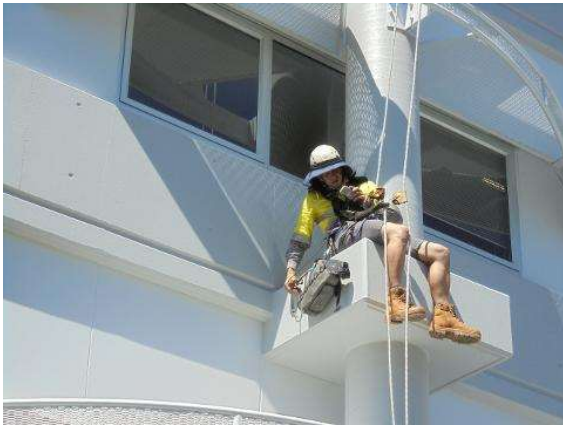
Dry Film Thickness (DFT) readings taken on the OFC window panels of the elevation.

#	\bar{x}	σ	↓	↑
Layer 1	15	526.9	121.7	362	722

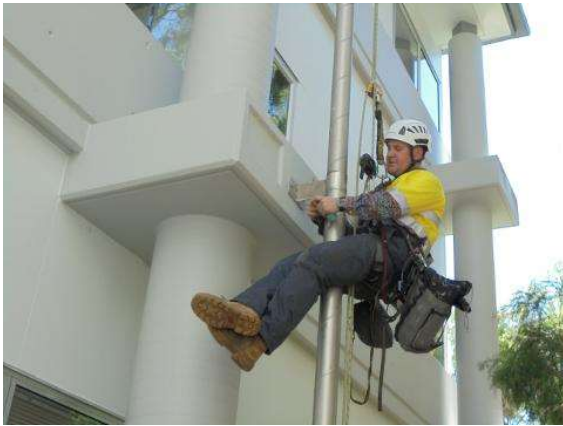
Dry Film Thickness (DFT) readings taken on the OFC column base tops of the elevation.

#	\bar{x}	σ	↓	↑
Layer 1	15	714.1	172.1	460	1027

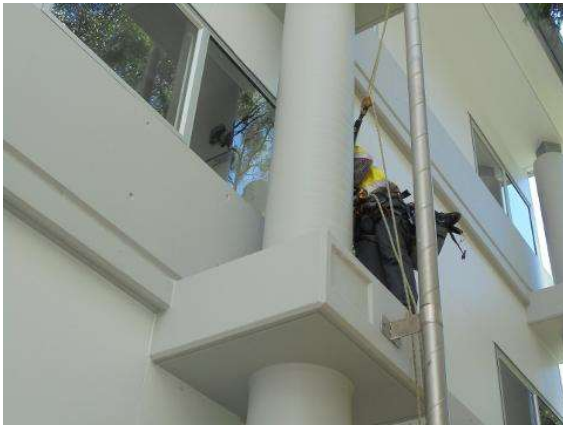
Dry Film Thickness (DFT) readings taken on the OFC column base sides of the elevation.

#	\bar{x}	σ	↓	↑
Layer 1	15	764.1	197.4	400	1071

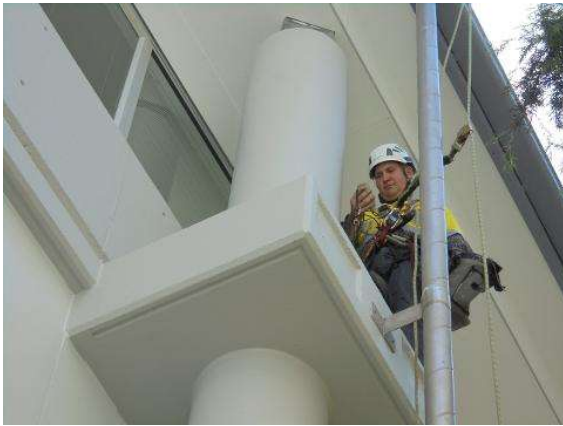
Dry Film Thickness (DFT) readings taken on the OFC columns of the elevation.

#	\bar{x}	σ	↓	↑
Layer 1	15	712.5	129.7	556	1023

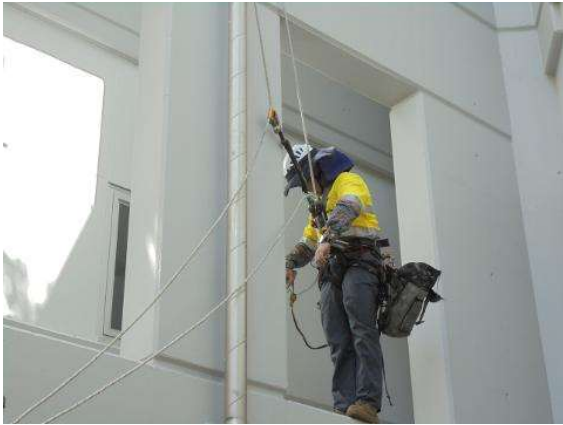
Dry Film Thickness (DFT) readings to the lower areas both internally and externally to the concrete panels at this location.

#	\bar{x}	σ	↓	↑
Layer 1	15	737.3	144.2	445	1003

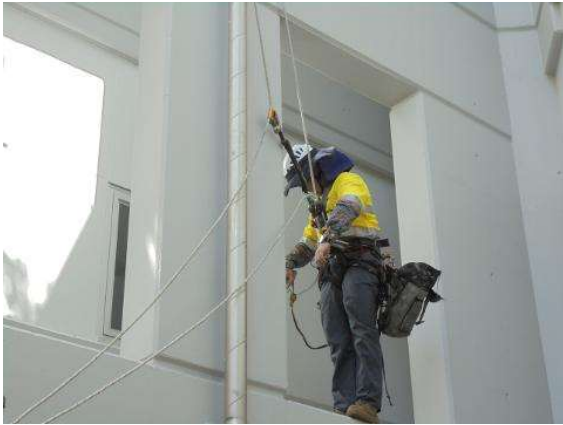
Dry Film Thickness (DFT) readings to the middle areas both internally and externally to the concrete panels at this location.

#	\bar{x}	σ	↓	↑
Layer 1	15	592.0	164.9	377	908

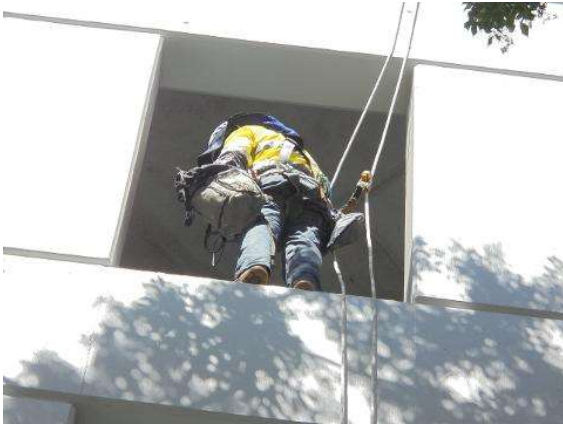
Dry Film Thickness (DFT) readings to the upper areas both internally and externally to the concrete panels at this location.

#	\bar{x}	σ	↓	↑
Layer 1	15	622.6	140.1	399	884

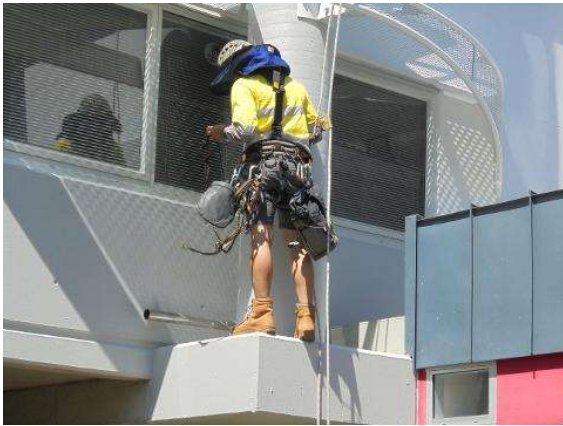
Dry Film Thickness (DFT) readings to the OFC window panels to this location.

#	\bar{x}	σ	↓	↑
Layer 1	15	569.3	109.6	418	738

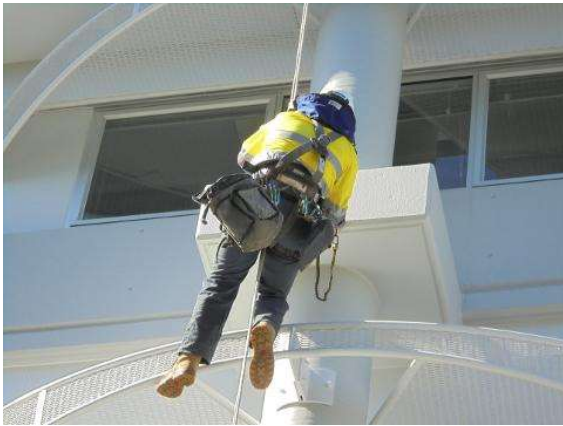
Dry Film Thickness (DFT) readings to the OFC column base tops to this location.

#	\bar{x}	σ	↓	↑
Layer 1	15	537.4	105.1	379	694

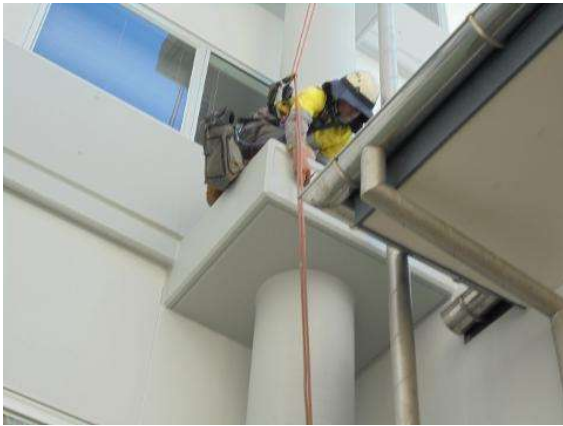
Dry Film Thickness (DFT) readings to the OFC Column base sides to this location.

#	\bar{x}	σ	↓	↑
Layer 1	15	500.1	134.8	361	885

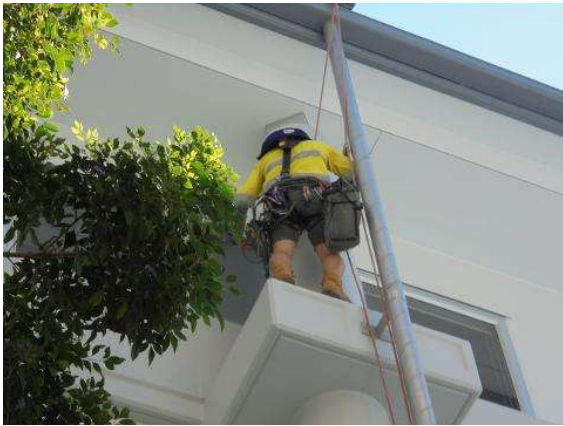
Dry Film Thickness (DFT) readings to the OFC columns to this location.

#	\bar{x}	σ	↓	↑
Layer 1	15	574.8	106.3	446	801

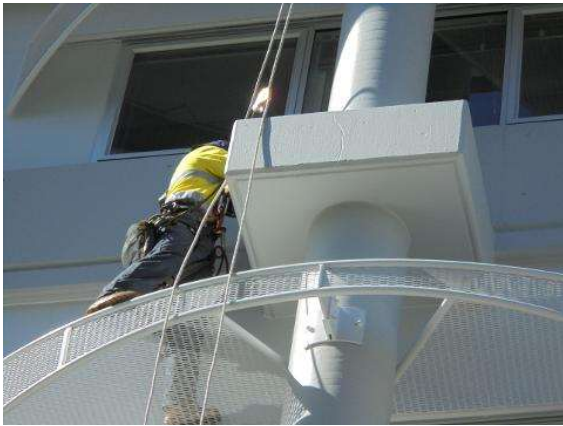
Dry Film Thickness (DFT) readings taken on the iOFC Window Panels to the elevation.

#	\bar{x}	σ	↓	↑
Layer 1	15	584.1	131.5	384	826

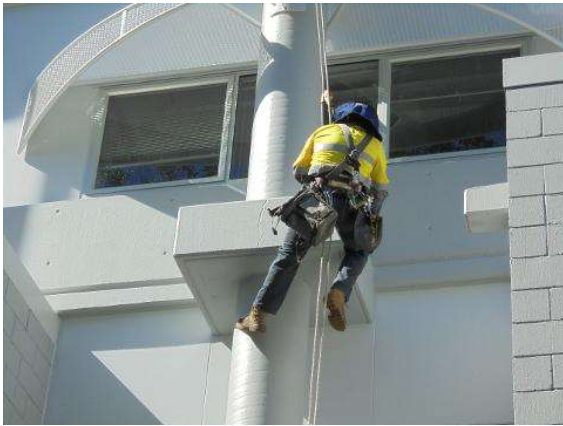
Dry Film Thickness (DFT) readings taken on the OFC column base sides of the elevation.

#	\bar{x}	σ	↓	↑
Layer 1	15	554.1	142.2	386	958

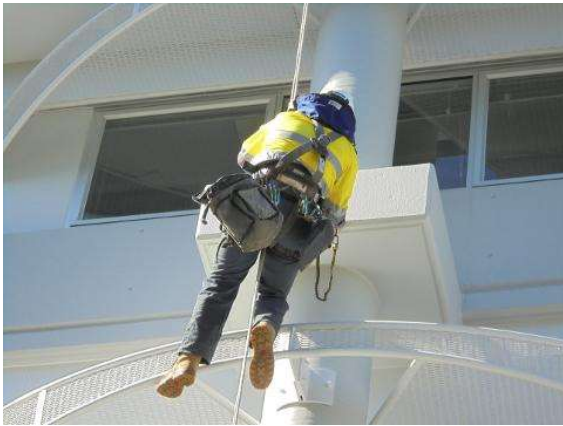
Dry Film Thickness (DFT) readings to the OFC column base sides in this location.

#	\bar{x}	σ	↓	↑
Layer 1	15	784.8	170.1	360	1025

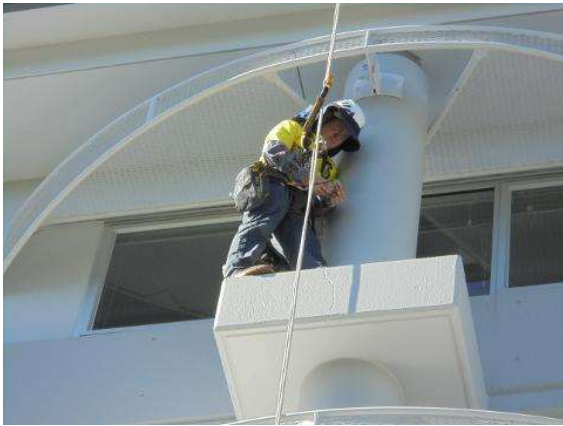
Dry Film Thickness (DFT) readings to the OFC column to this location.

#	\bar{x}	σ	↓	↑
Layer 1	15	691.7	186.4	415	1053

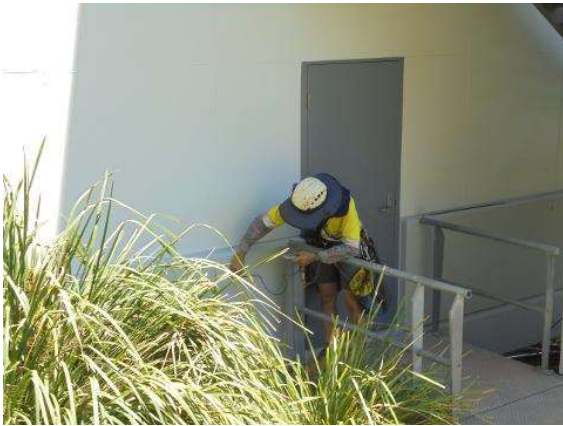
Dry Film Thickness (DFT) readings taken on the OFC beam of the elevation.

#	\bar{x}	σ	↓	↑
Layer 1	15	488.9	54.4	431	613

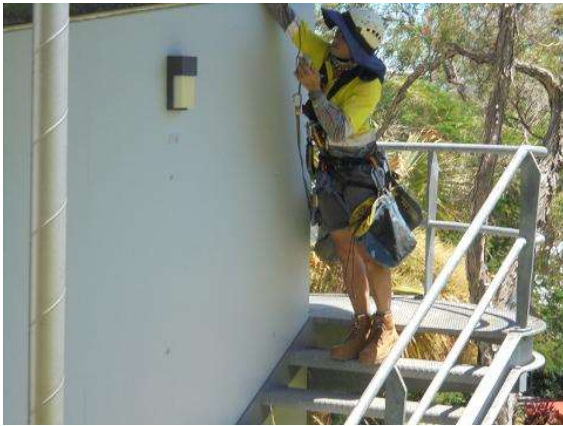
Dry Film Thickness (DFT) readings taken on the internal and external OFC end walls to level 1 of the elevation.

#	\bar{x}	σ	↓	↑
Layer 1	15	626.8	120.3	380	803

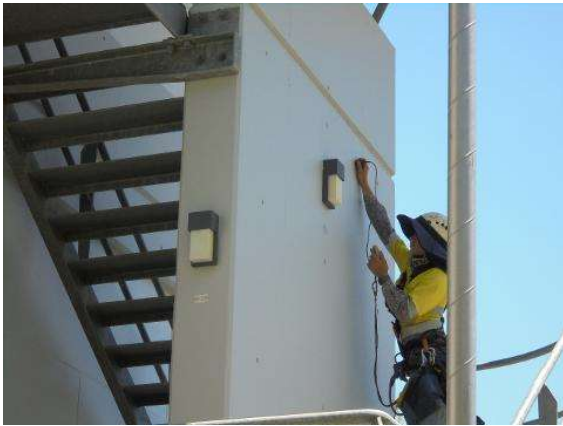
Dry Film Thickness (DFT) readings taken on the internal and external OFC end walls to level 2 of the elevation.

#	\bar{x}	σ	↓	↑
Layer 1	15	591.3	57.4	428	686

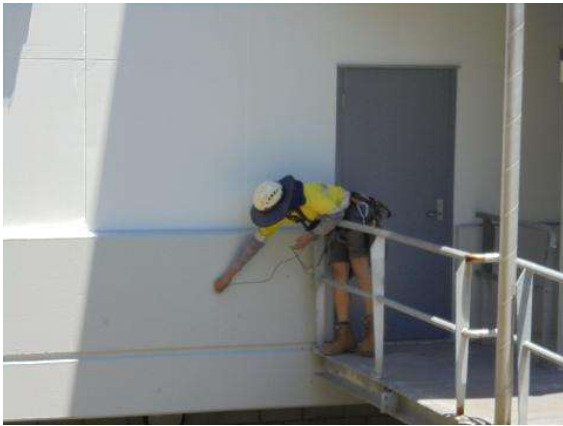
Dry Film Thickness (DFT) readings taken on the OFC Beam of the elevation.

#	\bar{x}	σ	↓	↑
Layer 1	15	529.1	84.6	401	685

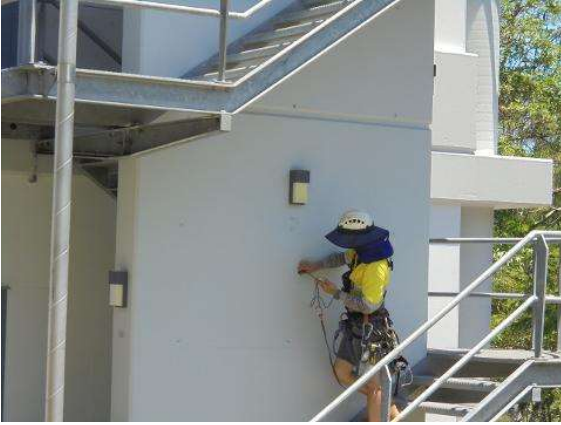
Dry Film Thickness (DFT) readings taken on the internal and external OFC end walls to level 1 of the elevation.

#	\bar{x}	σ	↓	↑
Layer 1	15	617.3	174.0	454	1020

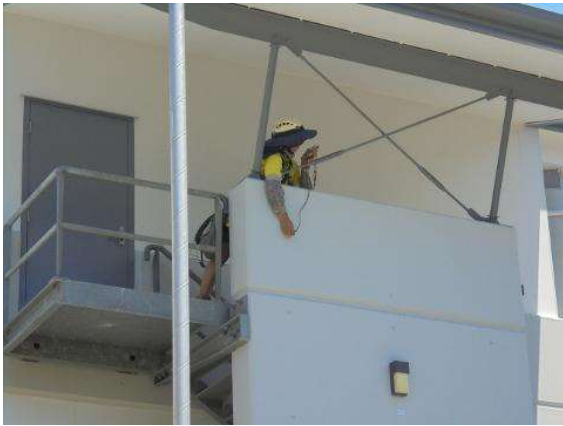
Dry Film Thickness (DFT) readings taken on the internal and external OFC end walls to level 2 of the elevation.

#	\bar{x}	σ	↓	↑
Layer 1	15	610.5	86.7	501	787
